Project Title: Reactive Sputtering of Tin and Solid Lubricants and Shear Strength Testing of Solid Lubricants

Project No: E-25-630

Sponsor: Hughes Aircraft Company

FINAL REPORT

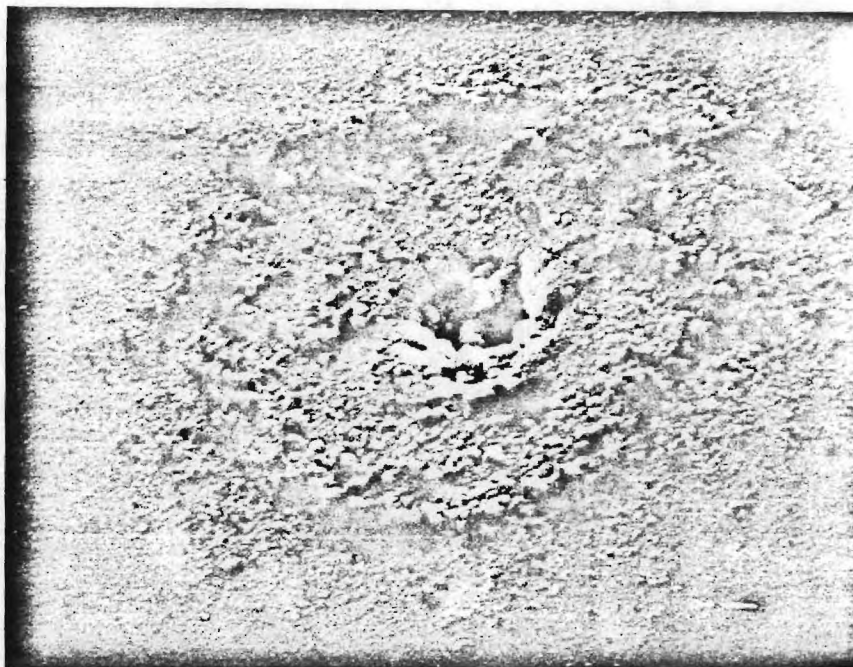
Figure 1.b. Same as above at 1500X. Reaction products
 at pit locations produces poorly bonded
 TiN in the vicinity of pits.

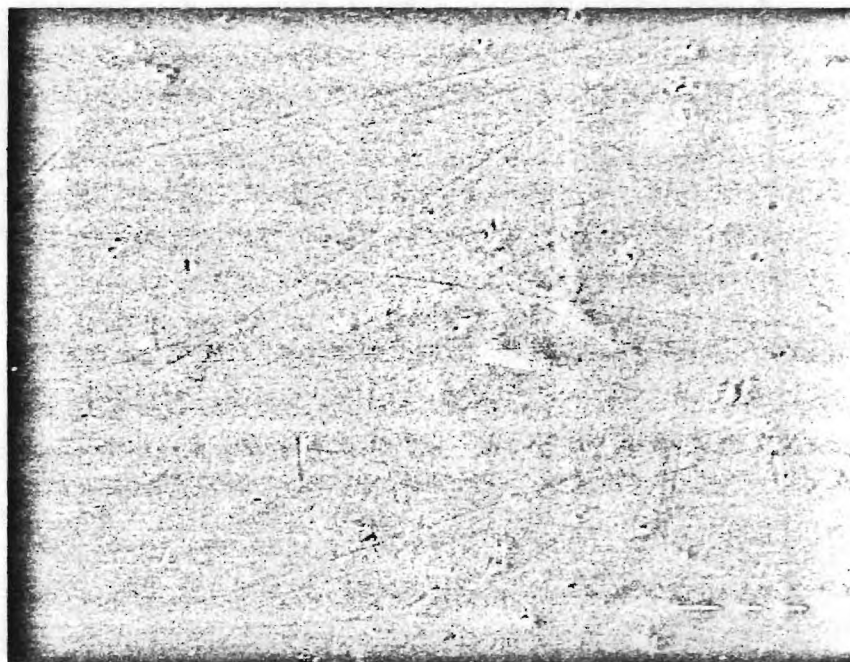
Figure 2.a. TiN coated surface of Faville-6 test sample prepared with Oakite HD-126 cleaning agent. Magnification 650X.

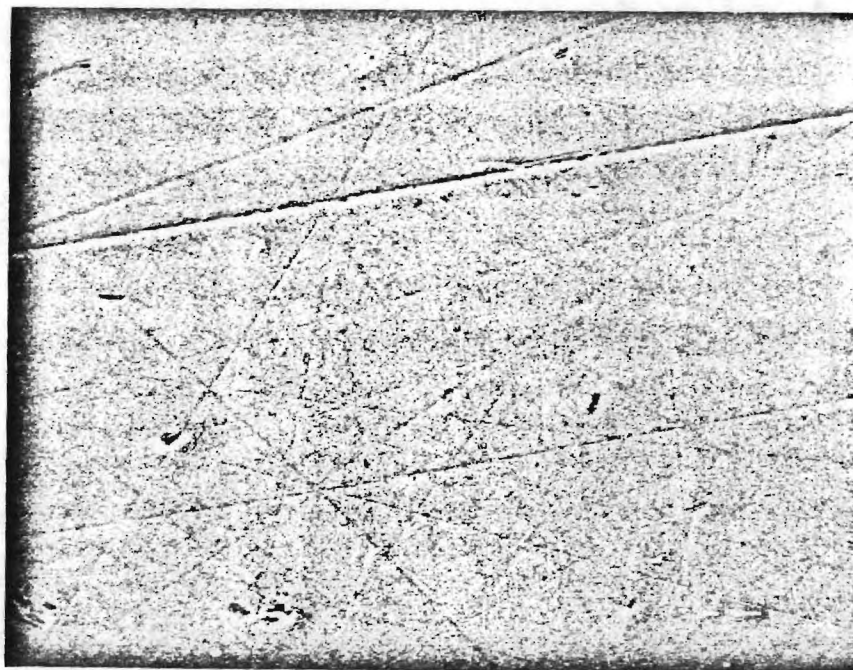
Figure 2.b. Same as above at 1200X. Note carbide pull out at isolated locations in the original surface of the test sample.

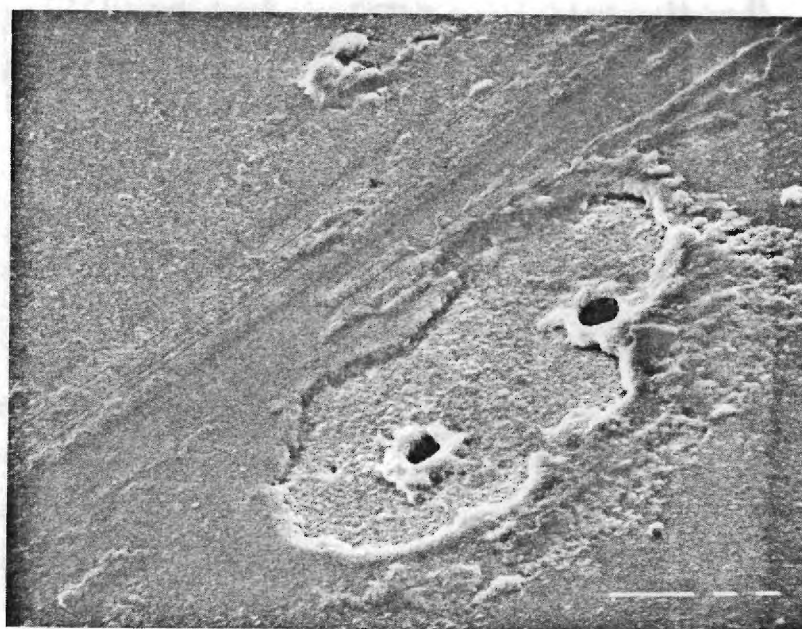
Figure 10. Duplex-coated, disc-to-disc LFW-6 test sample (A) before and (B) after sliding friction test at 1000 X and 1200 X respectively. There is little film loss at pitting artifacts.

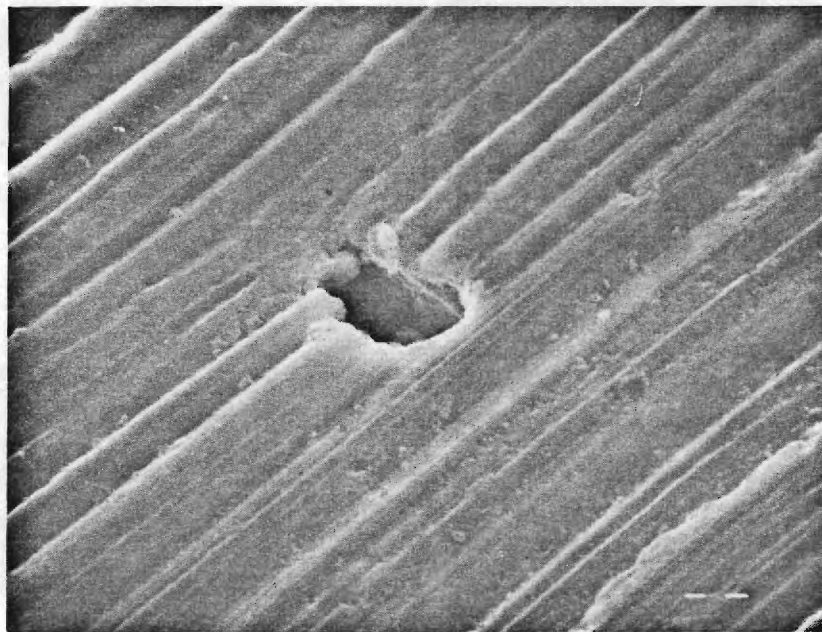
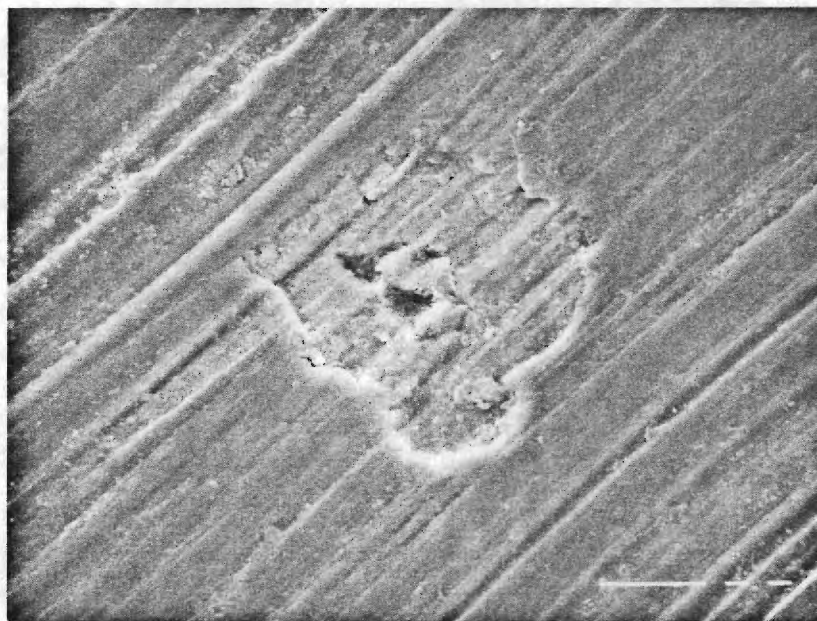
Figure 11. View of the TiN-coated ball track in the thrust bearing at 2600 X. Topography before rolling contact test is shown in (A). A similar location is shown at (B) at 1400 X following the rolling contact test. There is little film loss even at pitting artifacts.

The titanium nitride coated lower thrust bearing race was reassembled with a full complement of balls and the Delrin cage mentioned earlier. The assembly was tested in a LFW-6 test simulation rig with a thrust load of 450N which corresponds to a hertz contact stress of 1 GPa. The reactively sputtered TiN coats withstood the 30 minute test duration without coating failure. Figures 11 and 12 document the coating structure before and after the rolling contact test.

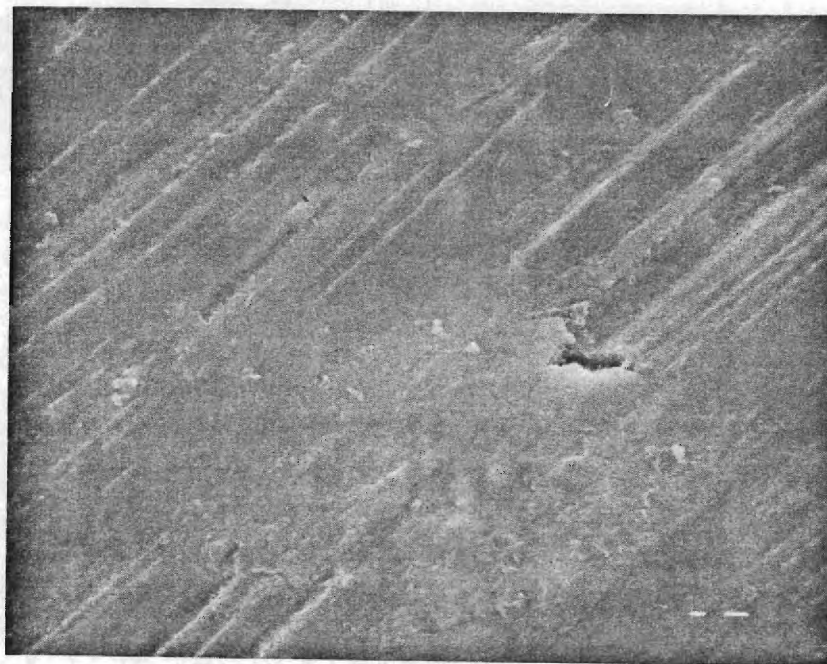
Figure 12. View of the ball track in (A) pure rolling region, and (B) in region with significant sliding. Micrographs at 2000 X and 1600 X respectively.

can be seen in Figure 12B. Even at locations of pitting artifact, there has been no film failure.

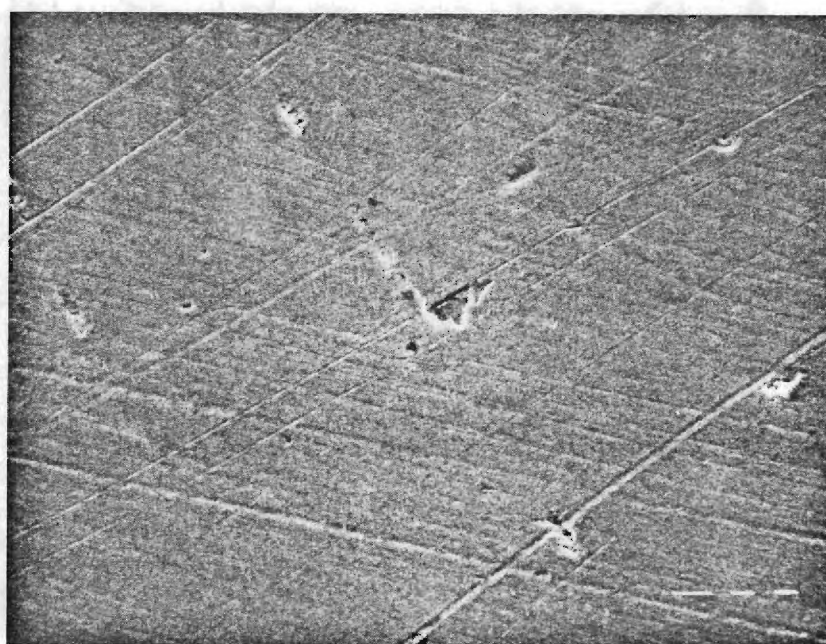
Figure 23. Topography of tungsten selenide coated traction disc (A) before and (B) after rolling contact tests in the concentrated contact test simulator. Magnifications are (A) 3600 X and (B) 520 X.

The appearance of the solid lubricant coated traction disc before and after use in the concentrated contact simulator is as shown in Figure 23. The film is free from nodular features and its upper surface faithfully reproduces the topography of the original disc surface. In pure rolling contact film damage is minimal as is apparent from Figure 23B. A low magnification view of the traction disc coated with the Westinghouse material is shown in Figure 24A. The appearance of the MoS_2 coated disc is similar. In both cases, debonding occurred at inner and outer radii of the traction disc where the sliding velocity exceeded (approximately) three to four percent of the rolling velocity. Figures 24B and 25A illustrate the appearance of the film-debonded regions at the inner and outer radii respectively. SEM observations show that the appearance of the MoS_2 -coated traction disc is quite similar to that of Westinghouse material coated traction discs at corresponding locations.
